## ARBORIST FIELD REPORT

Capitol Grounds (House)  
Structure and Site Drainage Design and Repair  
Parking Garages #29, #30 and #31  
400 South Monroe Street / Tallahassee, FL 32399

July 3, 2019  
CLA Project No. 265.001 / 2019

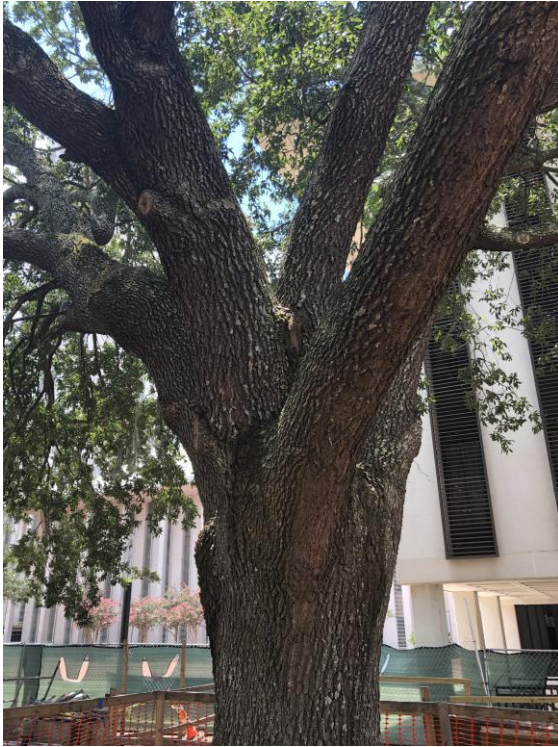
Live oak trees are often multi-trunked or develop a branching structure that does not contain a central leader. This type of co-dominate branching can form included bark in between the two competing branches, which can be a weaker union – resulting in a higher risk of splitting / failure.

Although the tree is in good condition, it exhibits a co-dominate branching structure, and a cause for new safety concerns. The presence of the newly observed cracks associated with several main co-dominate branches suggests the tree is at a higher risk of failure than normal. The exact risk potential is unknown, but considering the targets would be heavy pedestrian use, immediate action is recommended for the health, safety and welfare of the public. See photos (attached).

co-dominate branching in the upper trunk

For safety reasons, it is the preference of CLA and AAA to remove the tree and replant with a large specimen (or multiple smaller species) as directed by the project Landscape Architect (Patrick Hodges, R.L.A.)

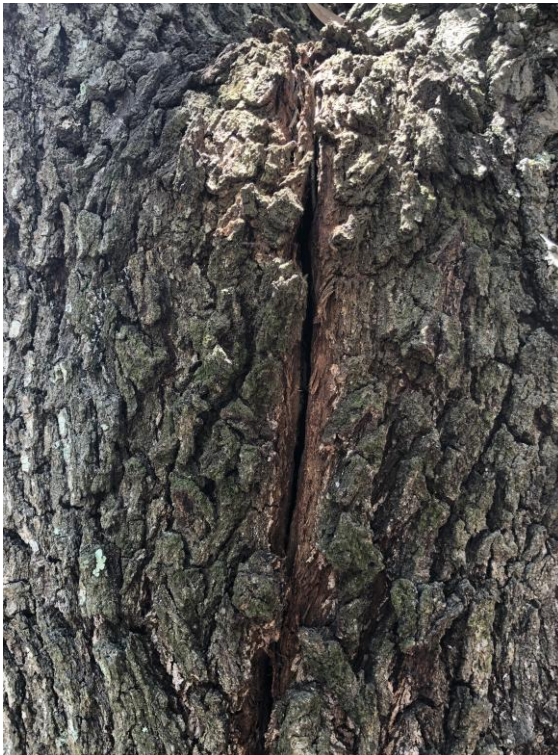
recent crack along branch union

If other solutions (to leave the tree in place) are pursued, then the previously proposed mitigation shall be performed, in conjunction with any risk abatement work in the canopy. The continual management and assessment will be essential if this tree is preserved.
